IMPORTANT - STOP USE AND INSPECT POTENTIAL CABLE FRAYING / BIRD-CAGING HALO & EDGE CABLE SELF-RETRACTING LIFELINES (SRLs)

This notice applies only to the Guardian SRL part #s listed herein, and only for products manufactured from January 1st, 2015 through March, 2017. A small number of these units have shown an increased potential for cable fraying at the swage and/or cable bird-caging. If these conditions are present, Guardian will repair affected units at no charge. This notice does not apply to new/unused units.

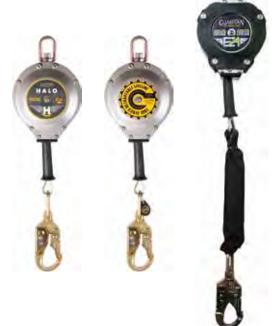
Inspect entire length of cable lifeline. Ensure lifeline shows no signs of fraying or bird-caging. Fraying exists if there is any evidence of broken cable strands, and bird caging exists if there is any evidence of separation of cable.

Pay special attention to any/all locations where swages come in contact with the lifeline, and at the point where the lifeline exits the unit housing. Cable swages may be located underneath rubber stopper or shrink tubing. It is permitted to cut away a portion of shrink tubing to inspect cable lifeline (never remove shrink tubing on shock absorber).
