Product Inspection Notice: **Immediate Action Required**

PRODUCT(S): Rebar Swivel Hook. Part numbers 01600, 01603, 01608, & 01611

INSPECTION PROCEDURE FOR S-3616 DAMAGED BOLT/NUT ON SWIVEL U-BLOCK

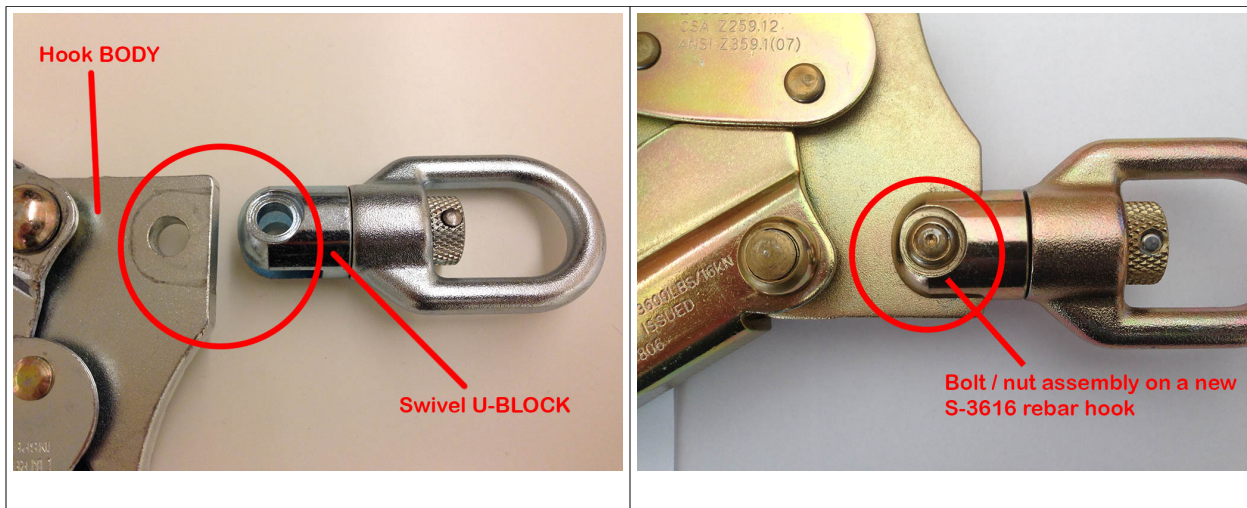
On 2014/1/3, we were notified of 2 S-3616 rebar hook failure from the field. The 2 rebar hooks were manufactured in early 2012, and are estimated to be in use for almost 2 years at the same site. The failure involves the detachment of the swivel u-block from the hook body, and the failure point is the threaded bolt/nut. The threaded bolt/nut on the 2 rebar hooks is lost in the field and could not be retrieved for investigation.

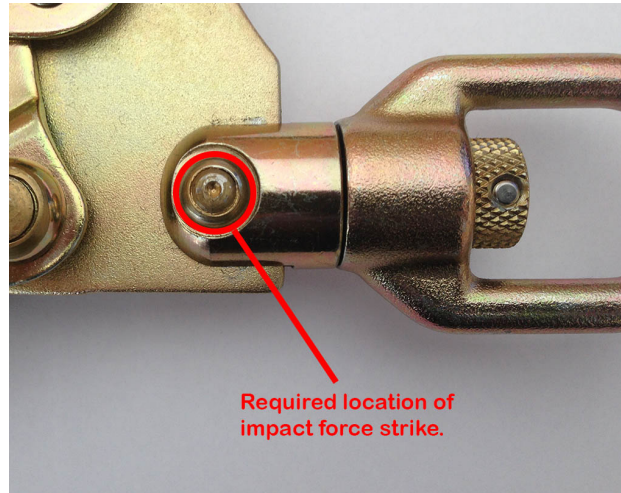
Further internal investigation into this field report revealed that repeated localized external impact force against the nut/thread could damage the nut thread and cause the nut to fail eventually. The eventual failure is from the last impact force to knock the nut off the bolt. It is not possible to un-thread the nut from the bolt, since the end of bolt thread is spun down. An example of external impact force would be the usage of a hammer by hand, striking it directly at the bolt/nut end. Below is a photo showing the required location for the external impact force (circle in red) :

In our investigation, a hook with damaged nut by impact force will exhibit symptom of abnormal gap/tolerance on the bolt / nut assembly. We kindly ask you to incorporate the below additional inspection procedure to your current ones.

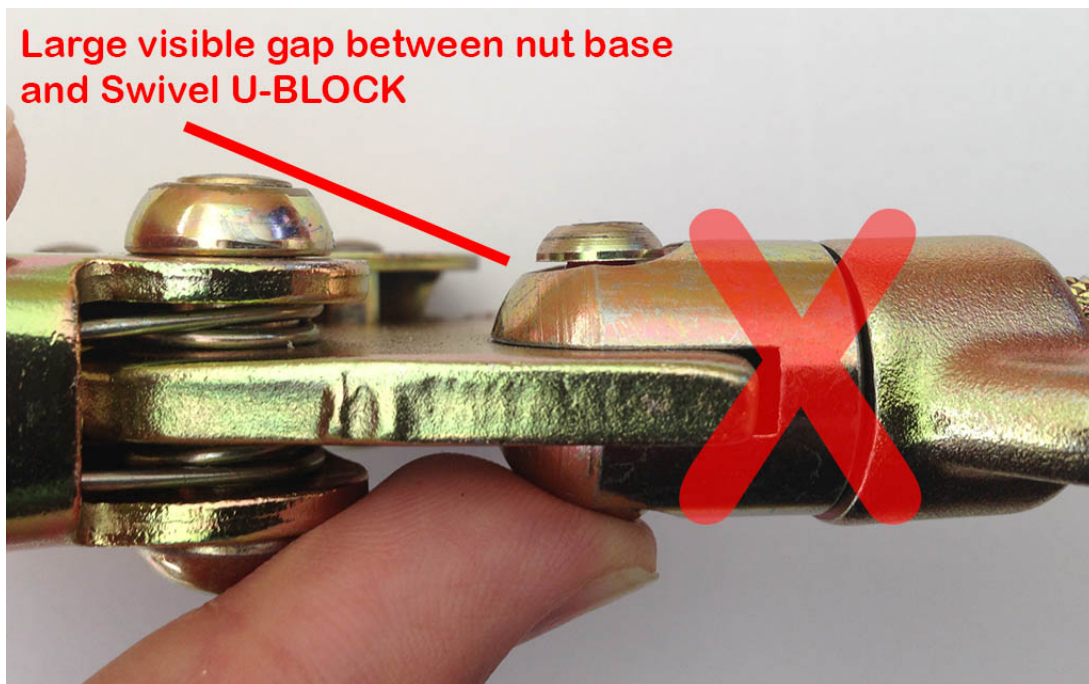
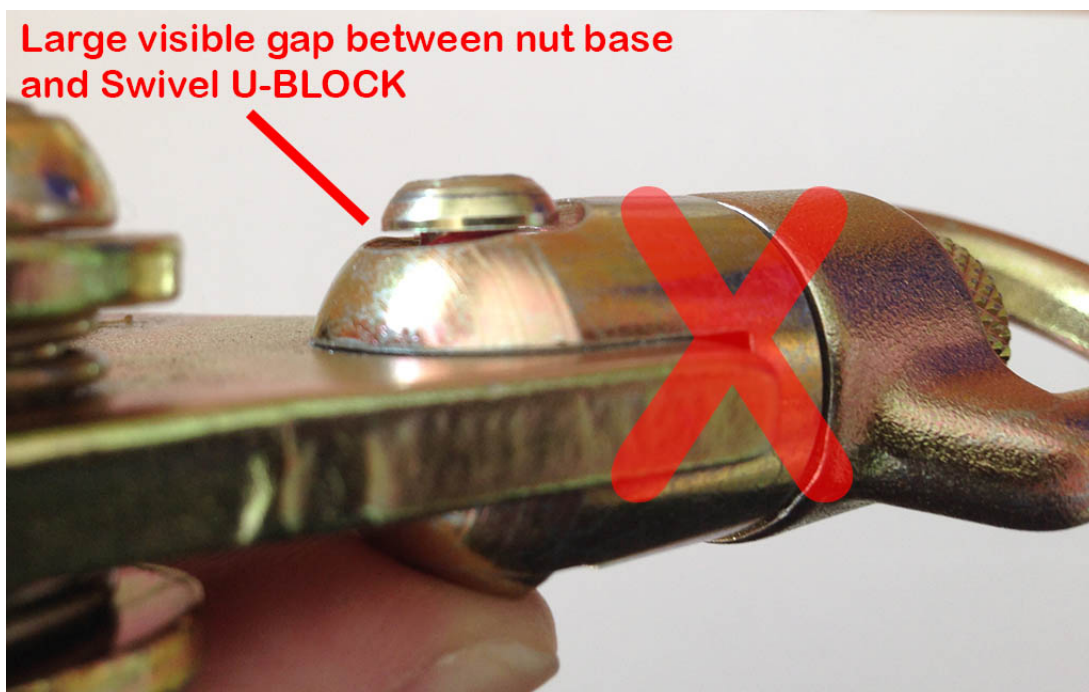
4. **Remove** the hook from use **immediately** if there is a large visible gap at the nut base. Below are example photos.

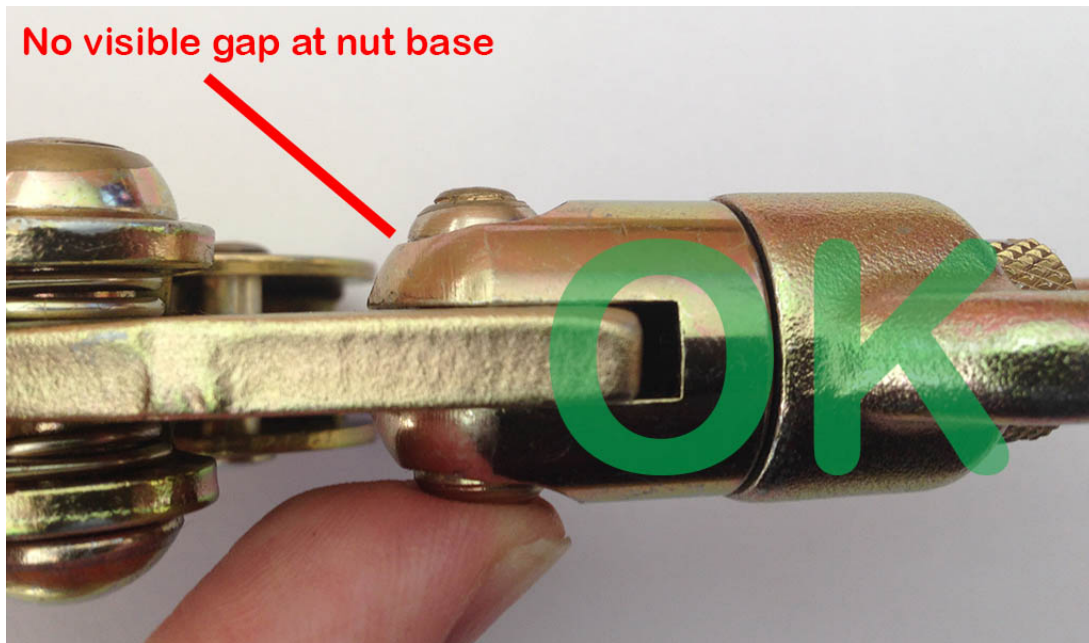
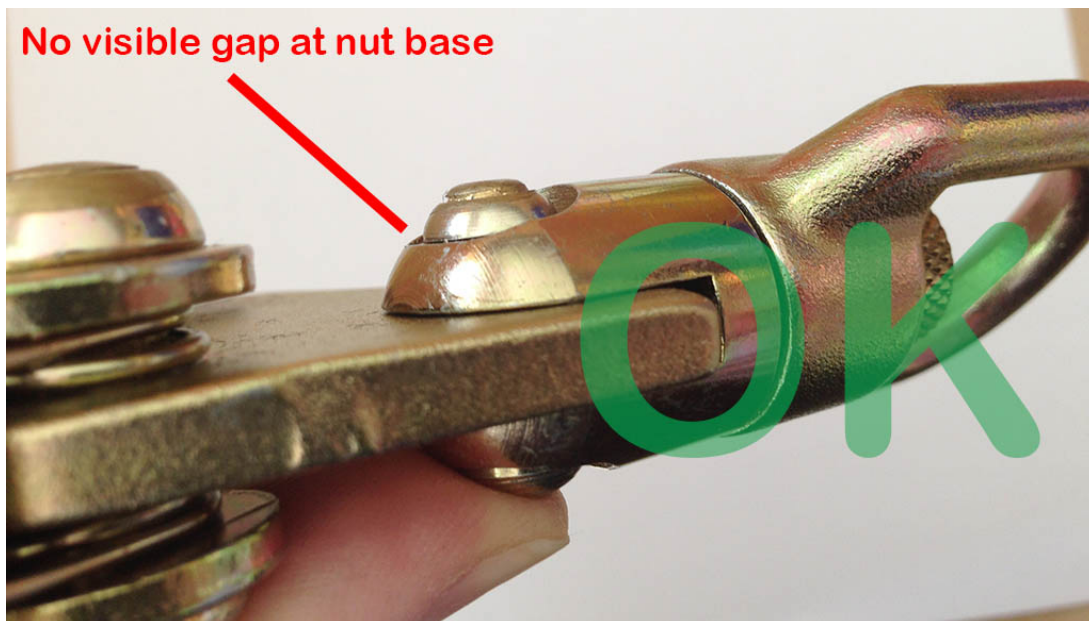
5. Below are example photos of good units where you could continue its usage.
