## **Product Inspection Notice:** **Immediate Action Required**

PRODUCT(S): Rebar Swivel Hook. Part numbers 01600, 01603, 01608, & 01611

## **INSPECTION PROCEDURE FOR S-3616 DAMAGED BOLT/NUT ON SWIVEL U-BLOCK**

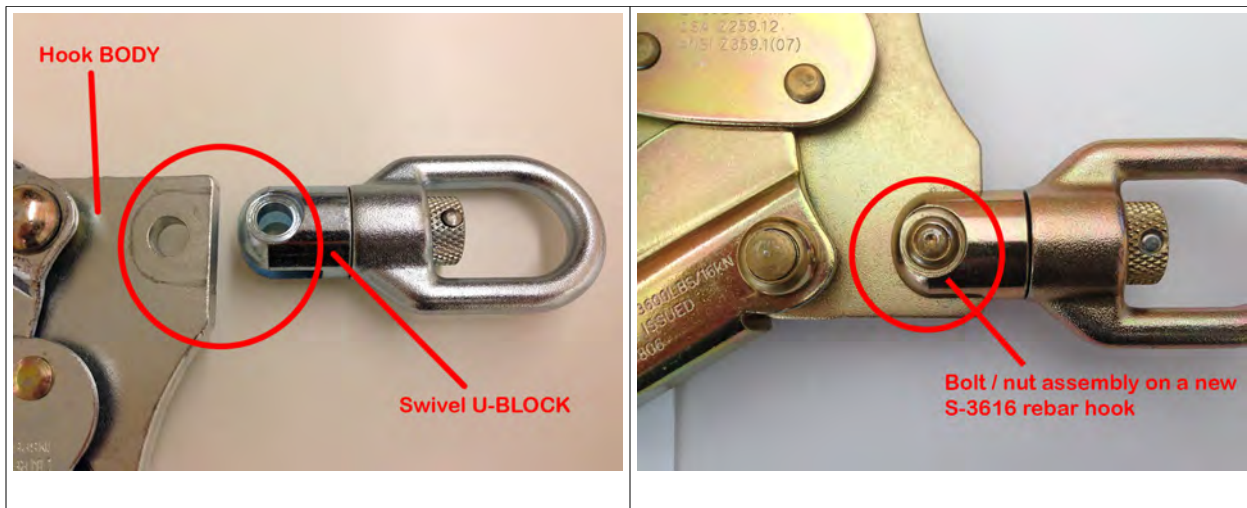
On 2014/1/3, we were notified of 2 S-3616 rebar hook failure from the field. The 2 rebar hooks were manufactured in early 2012, and are estimated to be in use for almost 2 years at the same site. The failure involves the detachment of the swivel u-block from the hook body, and the failure point is the threaded bolt/nut. The threaded bolt/nut on the 2 rebar hooks is lost in the field and could not be retrieved for investigation.

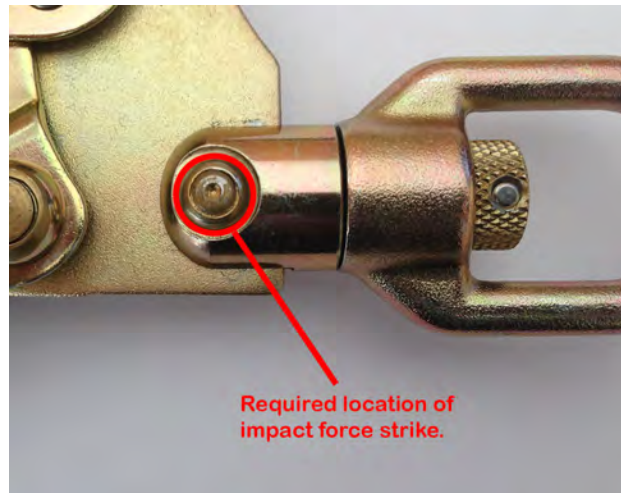
Further internal investigation into this field report revealed that repeated localized external impact force against the nut/thread could damage the nut thread and cause the nut to fail eventually. The eventual failure is from the last impact force to knock the nut off the bolt. It is not possible to un-thread the nut from the bolt, since the end of bolt thread is spun down. An example of external impact force would be the usage of a hammer by hand, striking it directly at the bolt/nut end. Below is a photo showing the required location for the external impact force (circle in red) :

In our investigation, a hook with damaged nut by impact force will exhibit symptom of abnormal gap/tolerance on the bolt / nut assembly. We kindly ask you to incorporate the below additional inspection procedure to your current ones.

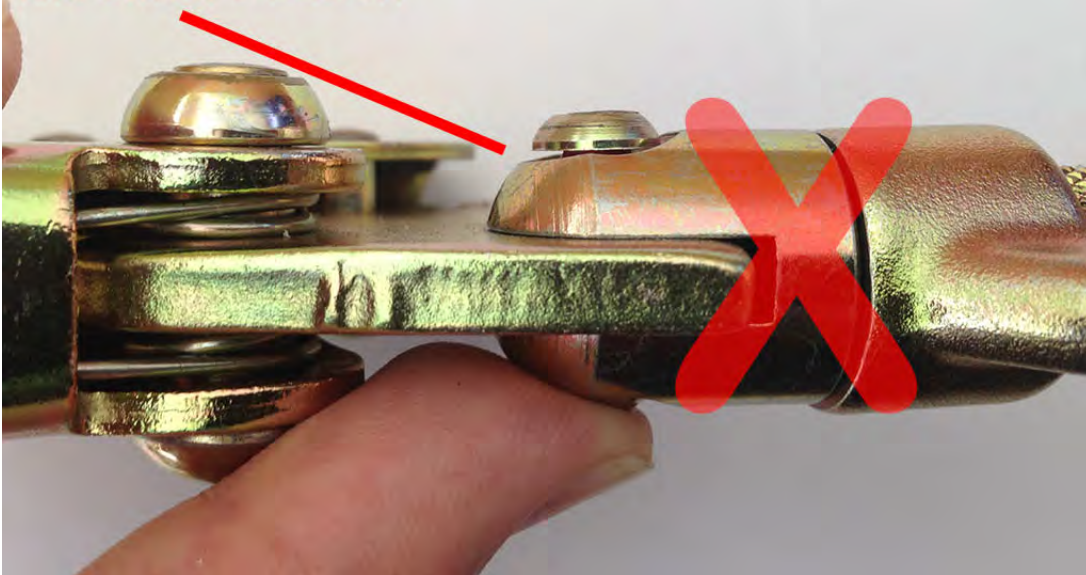
Large visible gap between nut base  
and Swivel U-BLOCK

4. **Remove** the hook from use **immediately** if there is a large visible gap at the nut base. Below are example photos.

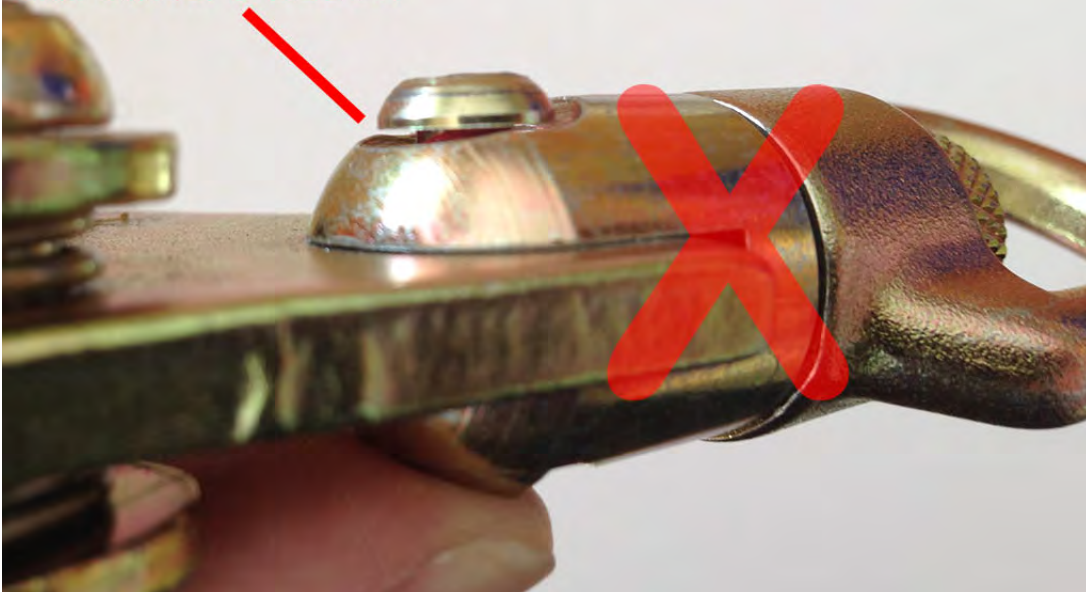
Large visible gap between nut base  
and Swivel U-BLOCK

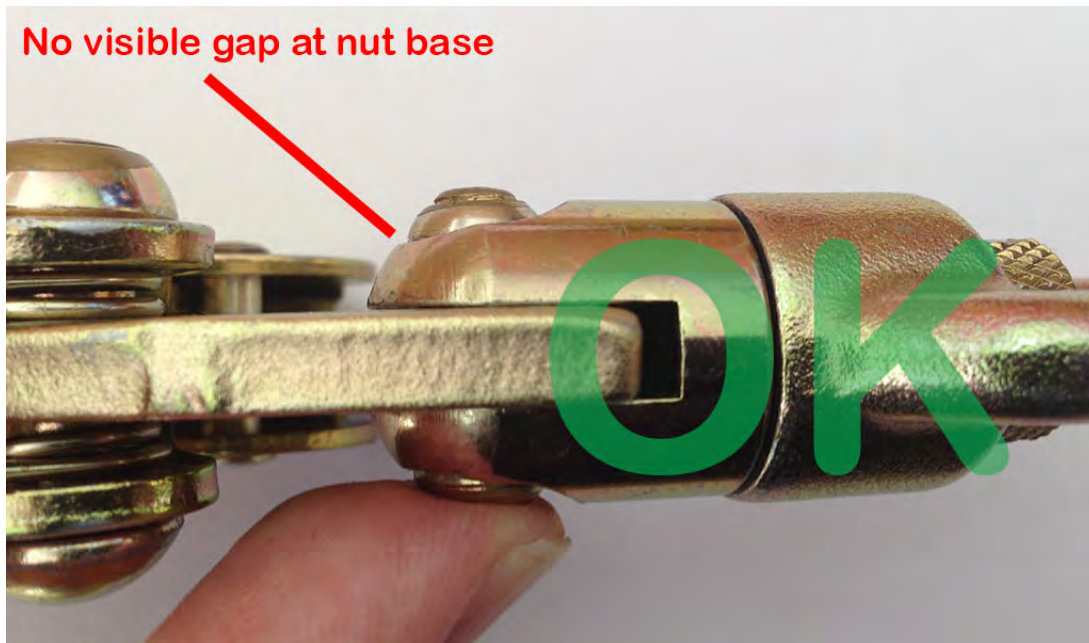
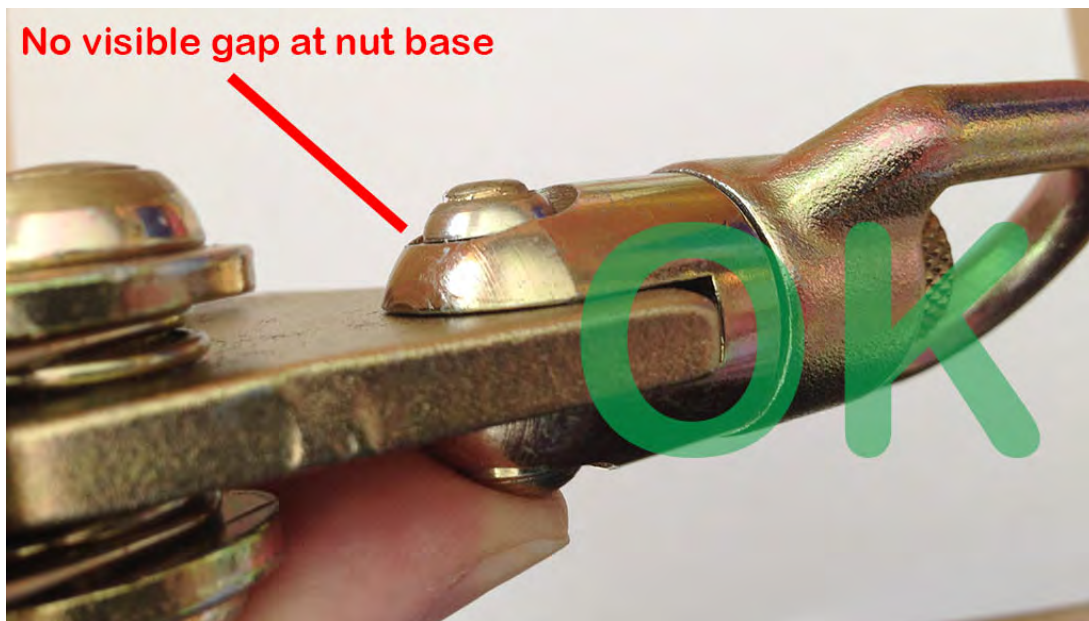
5. Below are example photos of good units where you could continue its usage.
