November 30, 2020

Stainless wire rope ferrule visual inspection procedure

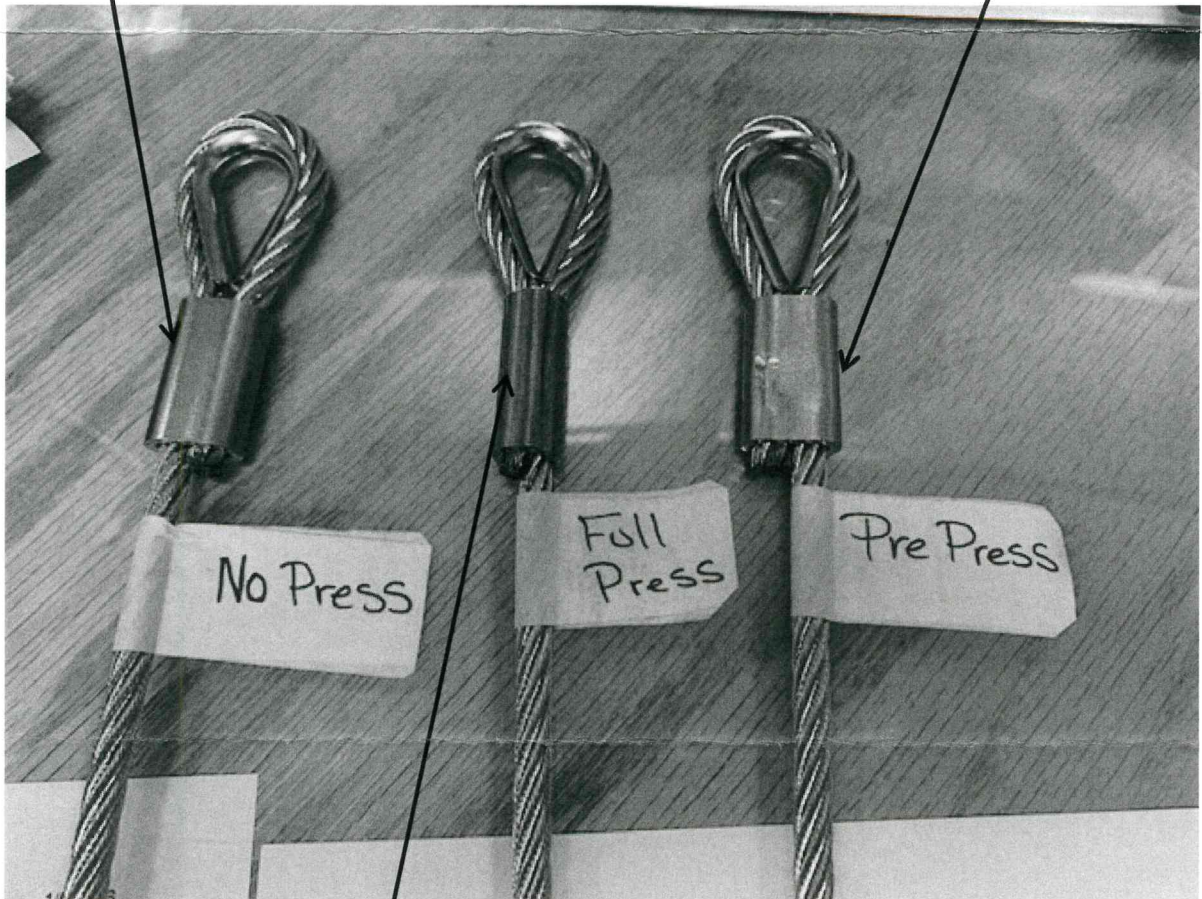
The affected wire rope assemblies were found to have an incorrectly crimped ferrule, allowing the wire rope to pull through the hook end ferrule. Thousands of wire rope assemblies were manufactured and shipped during this time period, with three reported failures. We are encouraging our customers and their end users to inspect stainless steel wire ropes manufactured during this period out of an abundance of caution.

Incorrectly crimped ferrule.
Not crimped.
Oval or rectangular in shape
around its circumference.

Incorrectly crimped ferrule.
Partially crimped.
Oval or rectangular in shape
around its circumference.

Correctly crimped ferrule.
Fully crimped.
Circular in shape around its
circumference.

3. Remove the wire rope assembly from service and **contact Thern** if the ferrule visually looks like the representation of either of these two incorrectly crimped conditions.

4. A wire rope assembly will have a correctly crimped ferrule if it visually looks like the representation of the correctly crimped condition.
