# SWIVEL SNAPHOOK INSPECTION NOTIFICATION

**Inspection notice for GFP products featuring a possible unsafe condition due to a supplier defect in a specific style of swivel snaphook supplied to Guardian between 8/26/2011 and 6/25/2012**

Date: 6/26/2012

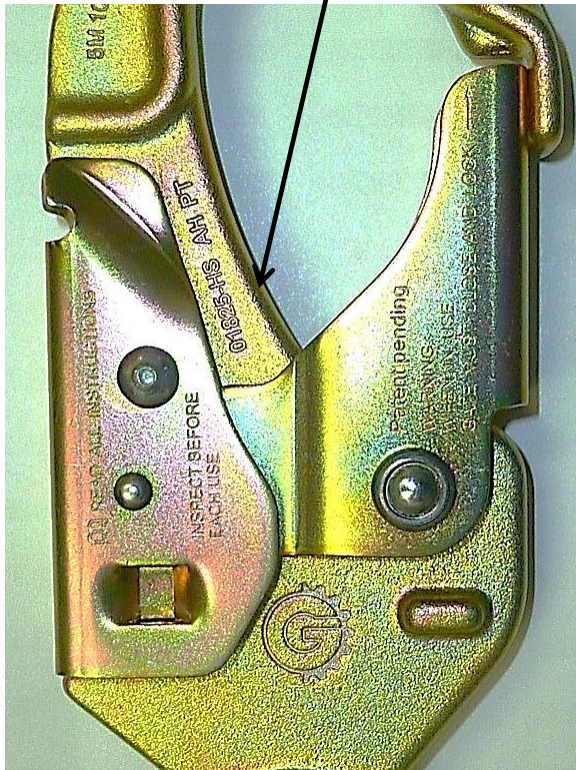
Marked with part # 01825-HS or 01826-HS on the hook body

Full photo of the potentially defective swivel snaphook.

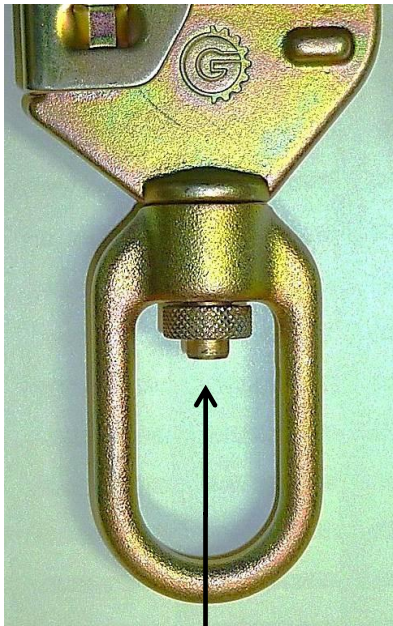
DEFECTIVE CONDITION

Use the photos below as guides for inspecting the hooks identified above. Inspect the swivel assembly for proper stem swaging. A properly swaged stem will form a mushroom shaped cap over the swivel nut. A defective snaphook will NOT BE SWAGED and will look like a stem protruding through the swivel nut without any swaging.

BAD HOOK. STEM PROTRUDES STRAIGHT THROUGH THE NUT. STEM HAS NO MUSHROOM SHAPE FLARED OVER THE NUT. NUT CAN BACK OFF THREADED STEM.

Remove the product from service immediately.

Contact Customer Service at GFP (800-466-6385) to be assigned a unique RQC- return number. Guardian will provide shipping instructions for returning products and coordinating replacements for units that have the defective swivel snaphooks. Guardian will replace the product and cover the freight costs.

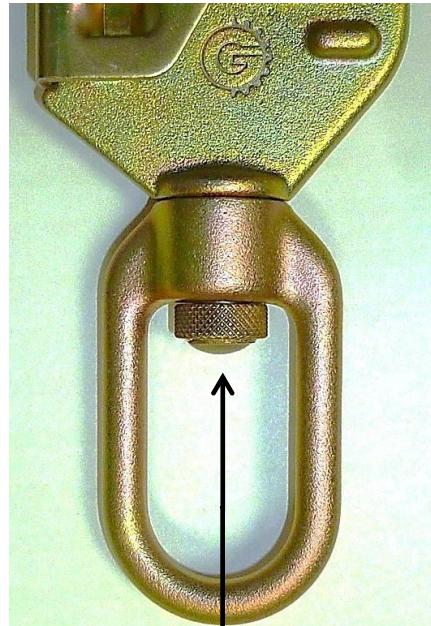
NORMAL CONDITION

NORMAL SWAGED HOOK. GOOD HOOK. STEM FLATTENED IN A MUSHROOM SHAPE. ANY SORT OF SWAGE MEANS HOOK IS GOOD. NUT CANNOT BACK OFF STEM.

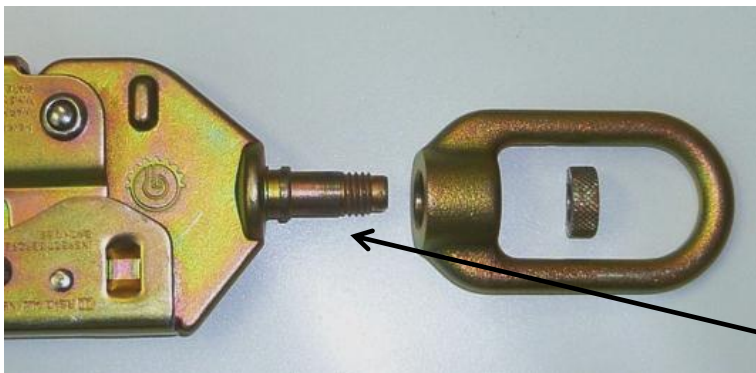
BAD HOOK. STEM OF HOOK BODY WAS NOT SWAGED OVER NUT. THREADED NUT IS CAPABLE OF SPINNING OFF THE STEM.
