END USER NOTIFICATION

IMPORTANT PRODUCT NOTIFICATION

RE: Lodestar NH Load Limiter Inspection Procedure

LODESTAR NH LOAD LIMITER INSPECTION PROCEDURE

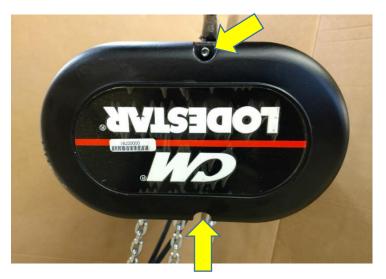
For ease of dissassembly and safety, orient the hoist on the brake end cover so the motor cover is facing directly upward as in the figure below.

- 1. Ensure the unit is not connected to any power source
- 2. Locate and remove the two 1/4-20 screws used to hold the motor cover to the hoist body.

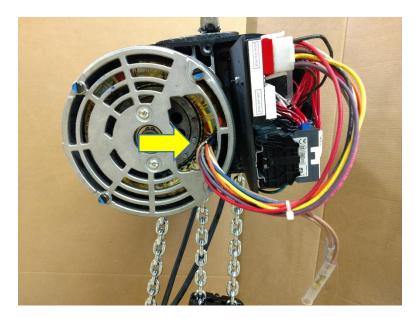
- 1. Install the load limiter in the hoist body
- 2. Install the motor in the hoist. The motor leads exiting the back of the motor need to be positioned at the 3 o'clock position when looking at the back of the motor. See the figure below.

- 3. Torque the motor mounting bolts 50 60 in*lbf in a criss-cross pattern.
- 4. Reconnect lead B1 and lead B2 into the correct socket position per the diagram below
