## **INSPECTION NOTICE**

## Inspection Procedure: HR125 & HR125M Hoist Ring

### Hinge Pin Check

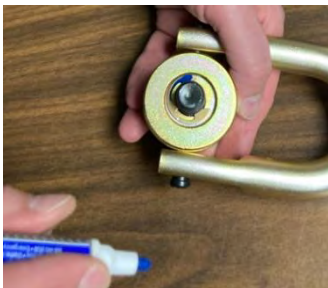
The inspection can be accomplished by taking a small flat rigid object (such as a thin pry bar) that can be inserted under the head of the hinge pin and prying outwardly on the hinge pin.

Alternately, the inspection can be accomplished by grabbing the head of the hinge pins (with small pliers) and pulling outwardly while twisting.

A small amount of axial movement of approximately 0.04" (1mm) may be detected, but the hinge pins should not come out of the bail and body of the hoist ring.

Additionally, the hinge pins should not rotate relative to the body.

Perform the inspection on both hinge pins.

After the inspection, the hoist rings should have an identifier added, that indicates the inspection was performed and found to be acceptable.

In this case we placed a blue paint pin dot next to the E-Clip.

If any hoist rings are found with inadequately secured hinge pins, please remove from service, and notify Crosby Technical Support at 1-800-220-8509 or [crosbytechsupport@thecrosbygroup.com](mailto:crosbytechsupport@thecrosbygroup.com) for immediate replacement.
