Product Inspection Notice: **Immediate Action Required**

PRODUCT(S): Rebar Swivel Hook. Part numbers 01600, 01603, 01608, & 01611

INSPECTION PROCEDURE FOR S-3616 DAMAGED BOLT/NUT ON SWIVEL U-BLOCK

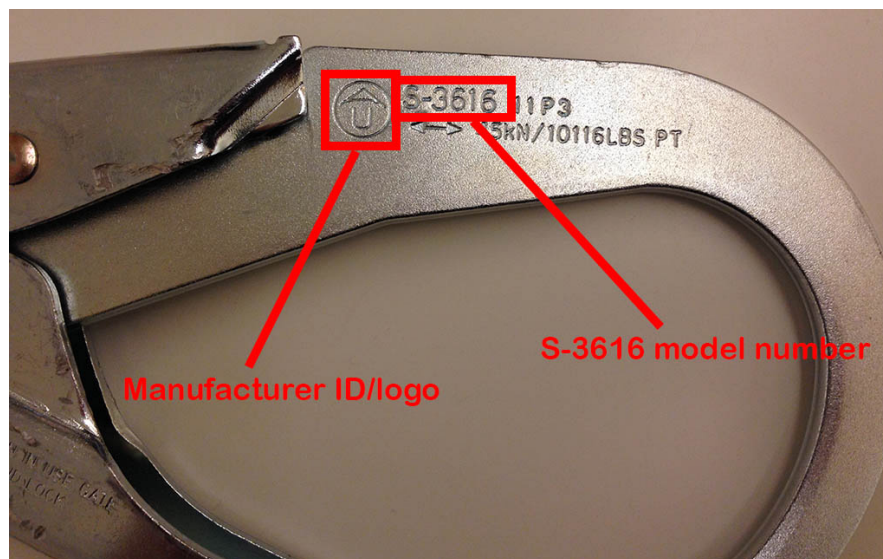
1. Identifying S-3616 rebar hook. There should be a "S-3616" model stamped/etched on the hook body. In addition, our manufacturer ID/logo is next to the model reference.

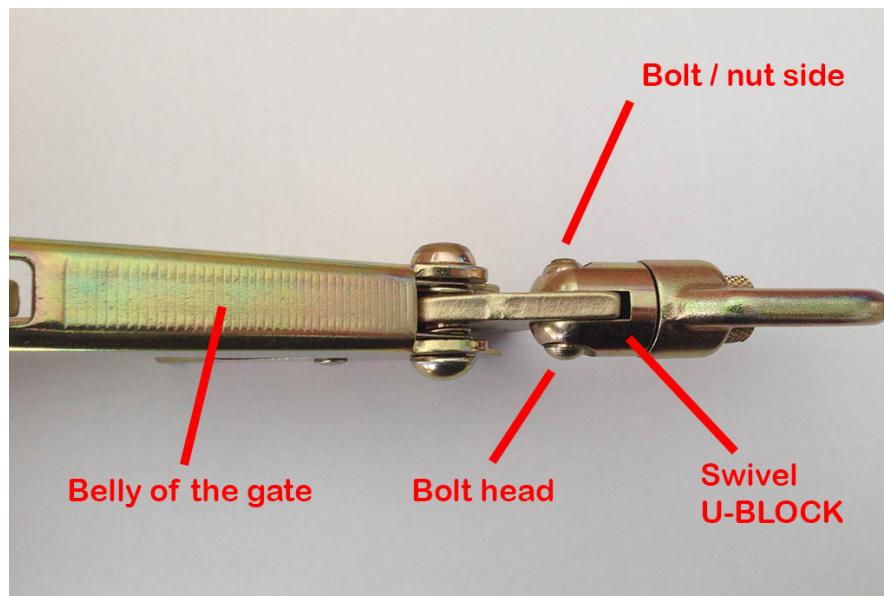
2. Hold the S-3616 rebar hook on an eye level with the bolt / nut side up and the belly of the gate facing towards you.

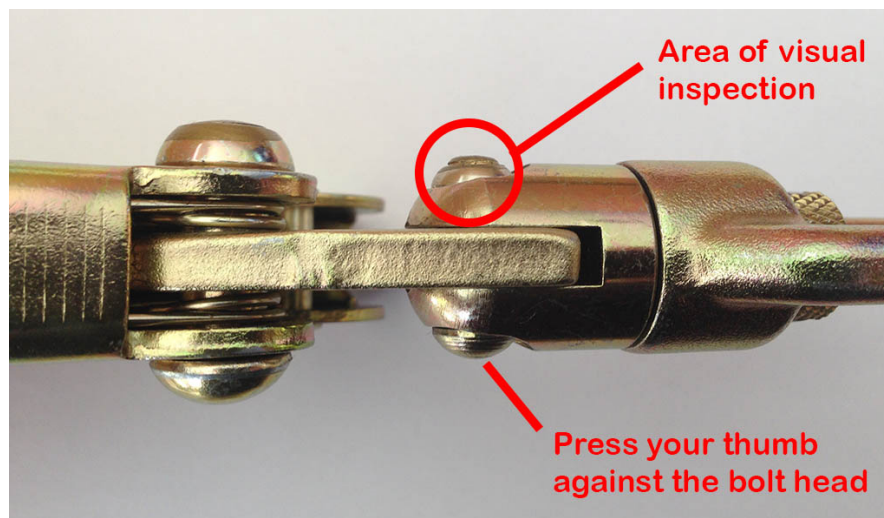
3. Press your thumb against the bolt head and push it upward. If there is abnormal gap/tolerance, you should feel it immediately where the bolt could be move up and down loosely in the Swivel U-BLOCK. Continue pressing your thumb against the bolt head and visually inspect the bolt / nut side. Please reference photos in step 4 for damaged units and step 5 for good units.
