## **Product Inspection Notice:** **Immediate Action Required**

PRODUCT(S): Rebar Swivel Hook. Part numbers 01600, 01603, 01608, & 01611

## **INSPECTION PROCEDURE FOR S-3616 DAMAGED BOLT/NUT ON SWIVEL U-BLOCK**

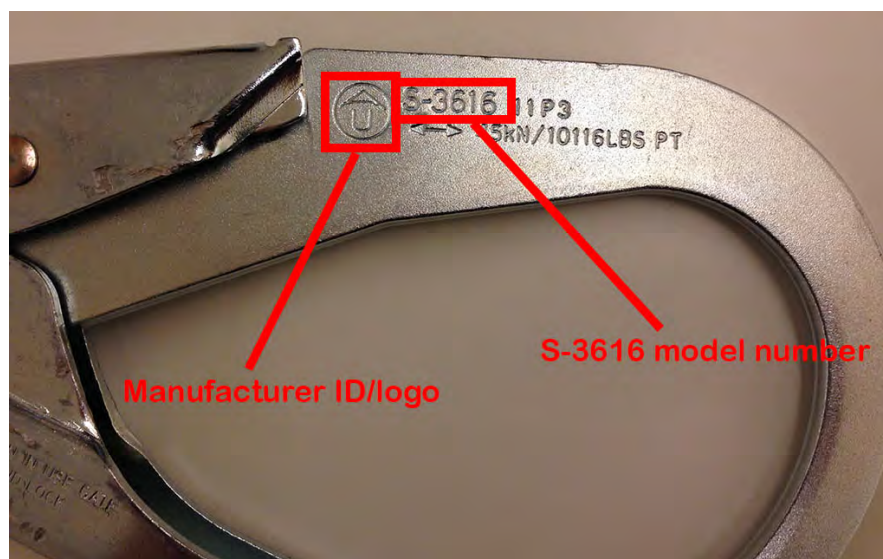
1. Identifying S-3616 rebar hook. There should be a "S-3616" model stamped/etched on the hook body. In addition, our manufacturer ID/logo is next to the model reference.

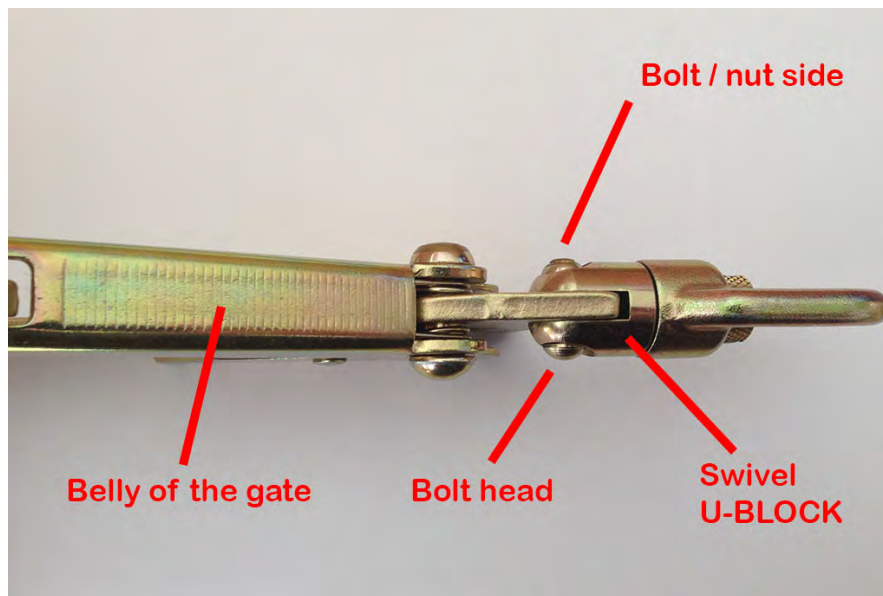
2. Hold the S-3616 rebar hook on an eye level with the bolt / nut side up and the belly of the gate facing towards you.

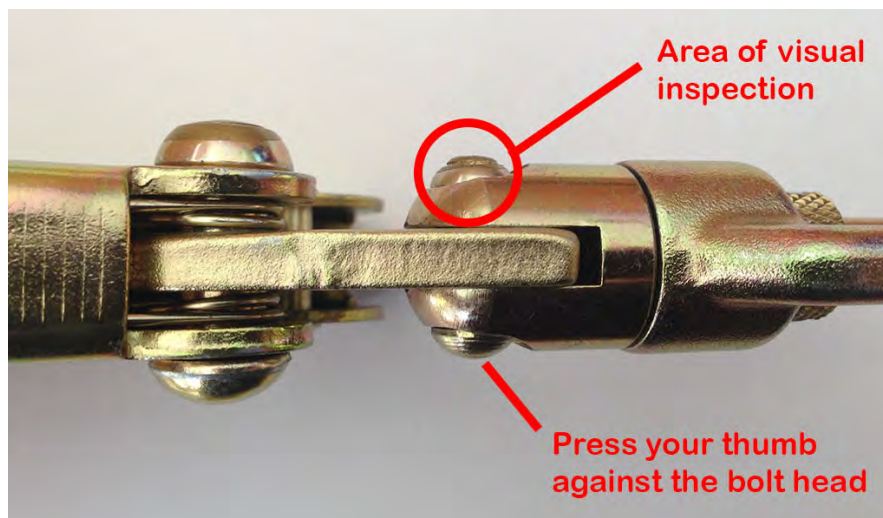
3. Press your thumb against the bolt head and push it upward. If there is abnormal gap/tolerance, you should feel it immediately where the bolt could be move up and down loosely in the Swivel U-BLOCK. Continue pressing your thumb against the bolt head and visually inspect the bolt / nut side. Please reference photos in step 4 for damaged units and step 5 for good units.
