END USER NOTIFICATION

IMPORTANT PRODUCT NOTIFICATION

RE: Lodestar NH Load Limiter Inspection Procedure

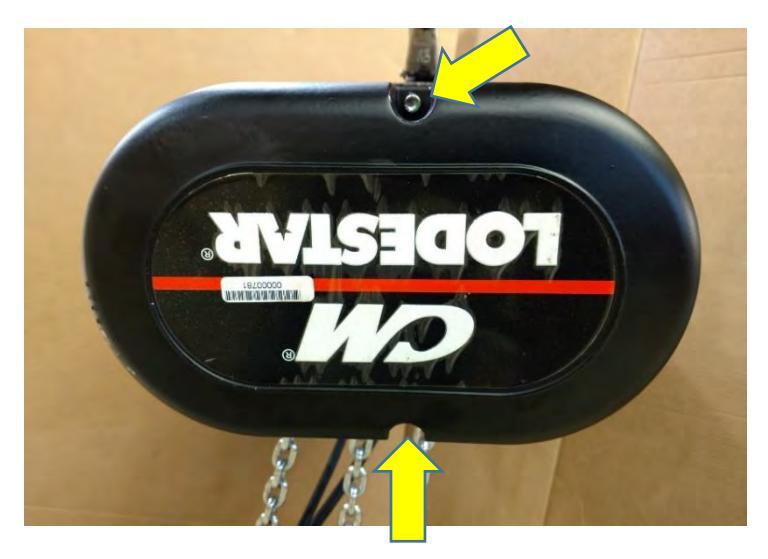
For ease of dissassembly and safety, orient the hoist on the brake end cover so the motor cover is facing directly upward as in the figure below.

- 1. Ensure the unit is not connected to any power source
- 2. Locate and remove the two 1/4-20 screws used to hold the motor cover to the hoist body.

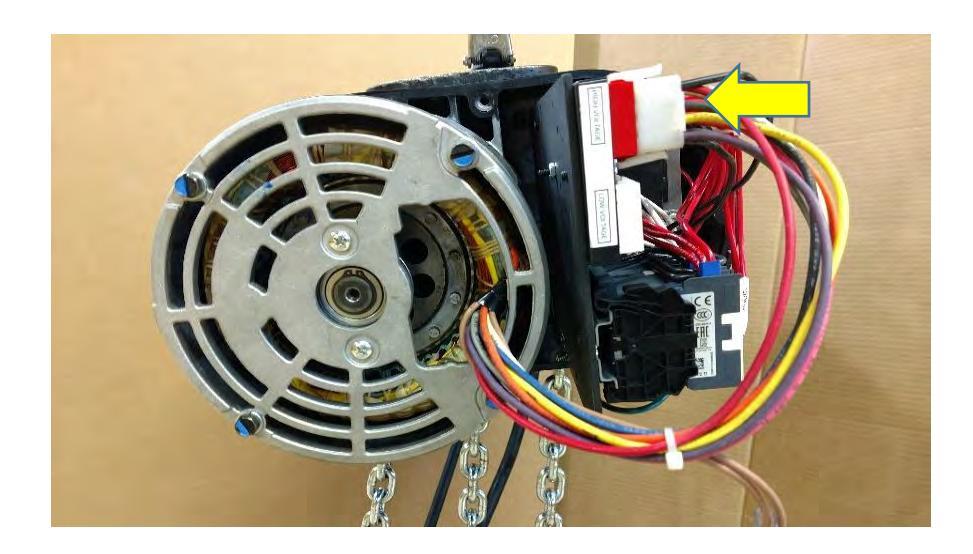
3. With the motor cover removed, unplug the 12 pin Molex connector from either the "HIGH VOLTAGE" socket or the "LOW VOLTAGE" socket located on the voltage change board.

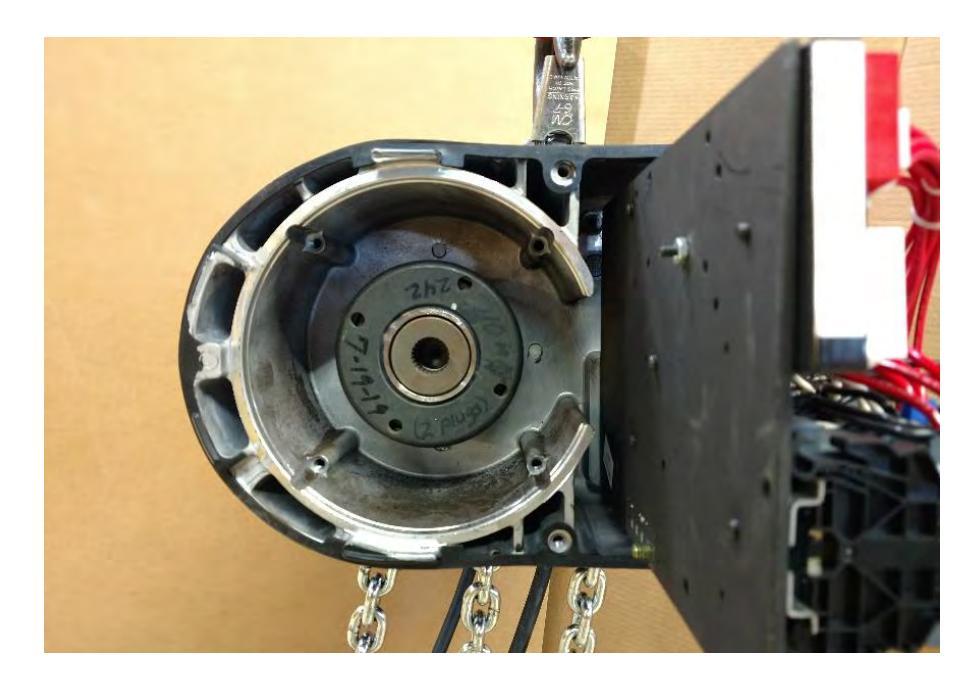
- 4. With a pin extraction tool (i.e. Molex p/n 11-01-0168) remove black lead B1 and black lead B2 from the Molex plug.
 - <image>
- 5. Next, remove the (4) $\frac{1}{4}$ -20 motor mounting bolts.

6. Remove the motor from the hoist body.

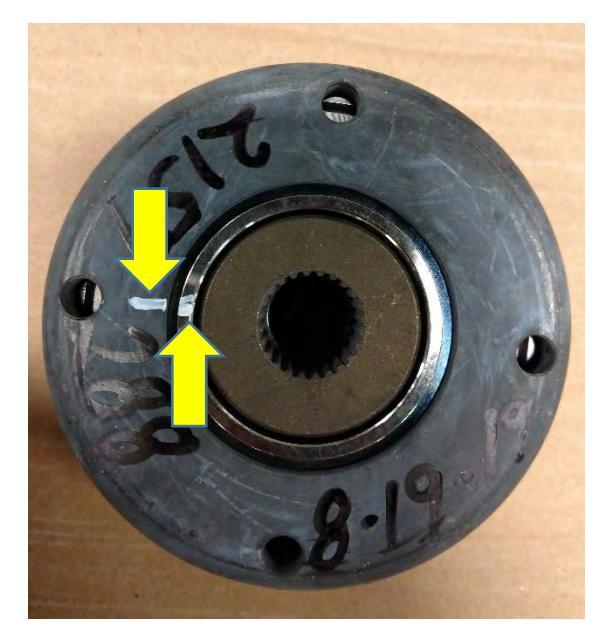
1. Verify the factory paint tick marks are aligned. Figure below shows a load limiter set at the factory setting and acceptable for reuse as long as replacement is not required due to normal wear.

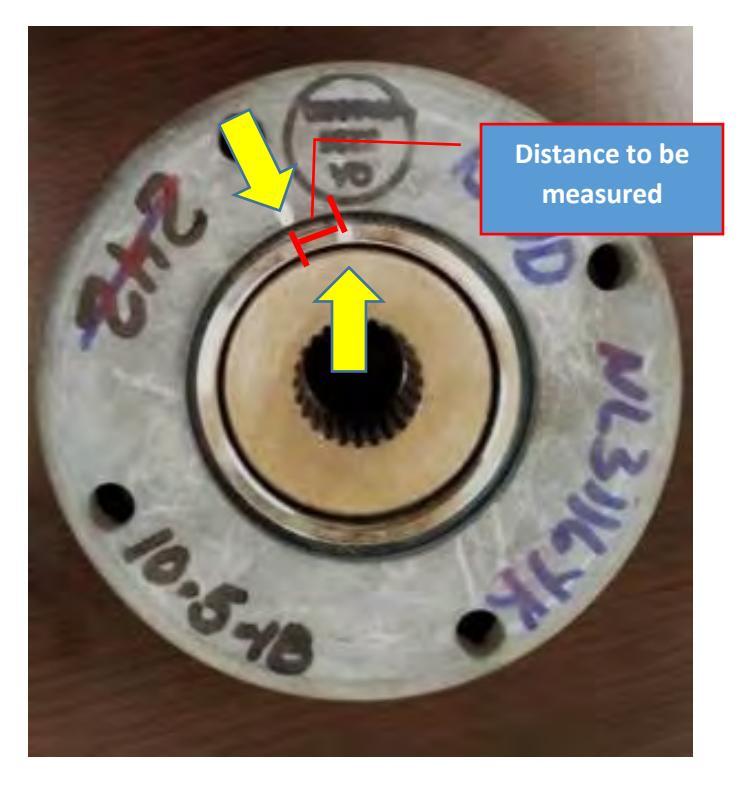
If the tick marks have separated, measure the distance between the marks as shown below. If the marks are **less than 0.25**" apart, the load limiter is acceptable for reuse as long as replacement is not required due to normal wear. If the marks are **more than 0.25**" apart in either the clockwise or counter clockwise position, the load limiter shall be replaced.

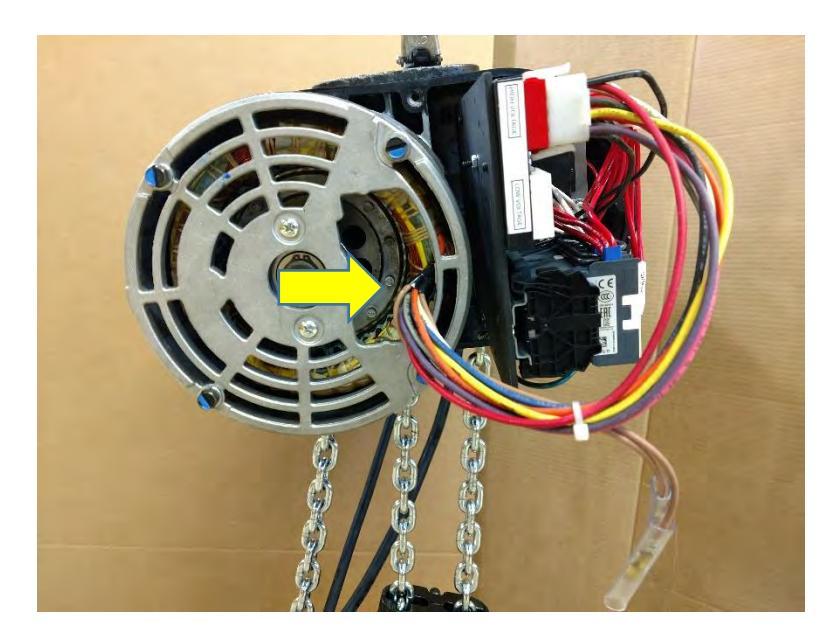
- 1. Install the load limiter in the hoist body
- 2. Install the motor in the hoist. The motor leads exiting the back of the motor need to be positioned at the 3 o'clock position when looking at the back of the motor. See the figure below.

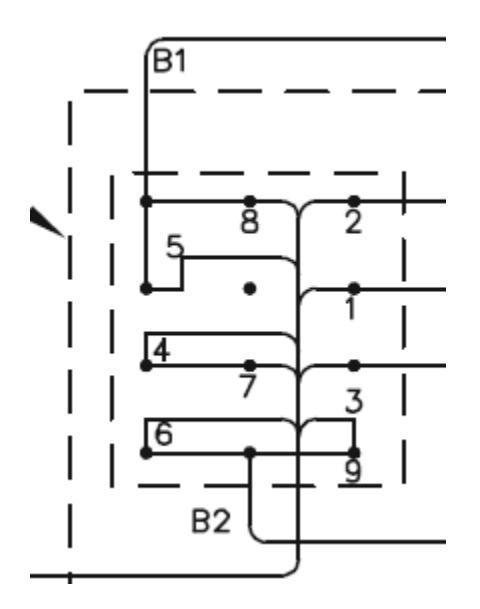
- 3. Torque the motor mounting bolts 50 60 in*lbf in a criss-cross pattern.
- 4. Reconnect lead B1 and lead B2 into the correct socket position per the diagram below

5. Plug the Molex connector into the proper connection (either HIGH VOLTAGE or LOW VOLTAGE) on the voltage change board

NOTE: BE SURE THE MOTOR PLUG HAS BEEN CONNECTED FROM THE POSITION TO WHICH IT WAS REMOVED. DAMAGE TO EQUIPMENT MAY OCCURE IF INCORRECLTY CONNECTED
