## IMPORTANT PRODUCT ISSUE NOTICE

### **PUSH BUTTON SWITCH ASSEMBLY FOR ED-DS DUAL SPEED ELECTRIC HOIST**

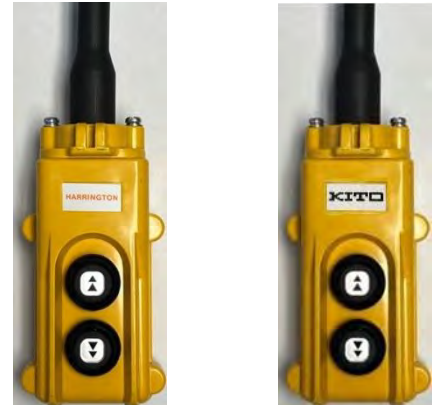
Harrington has become aware of an issue with a small number (less than 0.2%) of push button switch assemblies for the ED-DS dual-speed electric hoist. Potentially affected two-speed push button switch assemblies were shipped between November 17, 2021 and April 25, 2023 and will have a Harrington label (orange letters on white background) or a KITO label (black letters on white background). They may have been supplied as part of a finished ED-DS hoist, or as part of a push button switch assembly with cord complete set, or as a push button switch assembly. Enclosed is the list of products you purchased from Harrington that could be affected.

Buttons may not return to their off position after they are pressed and released.

1. Ensure products on the enclosed list are not used until it is confirmed they do not have this issue.
2. Inspect the product to determine if the push button switch assembly is potentially affected. Not all two-speed push button switch assemblies shipped between the aforementioned dates are affected. Those that are **NOT Affected** will have any of the following characteristics. Push button switch assemblies that do not have any of these characteristics are **potentially affected**.  
Characteristics of push button assemblies that are **NOT Affected**:
